3.4 Mechanical, Electrical, Plumbing, Fire Protection Existing Conditions

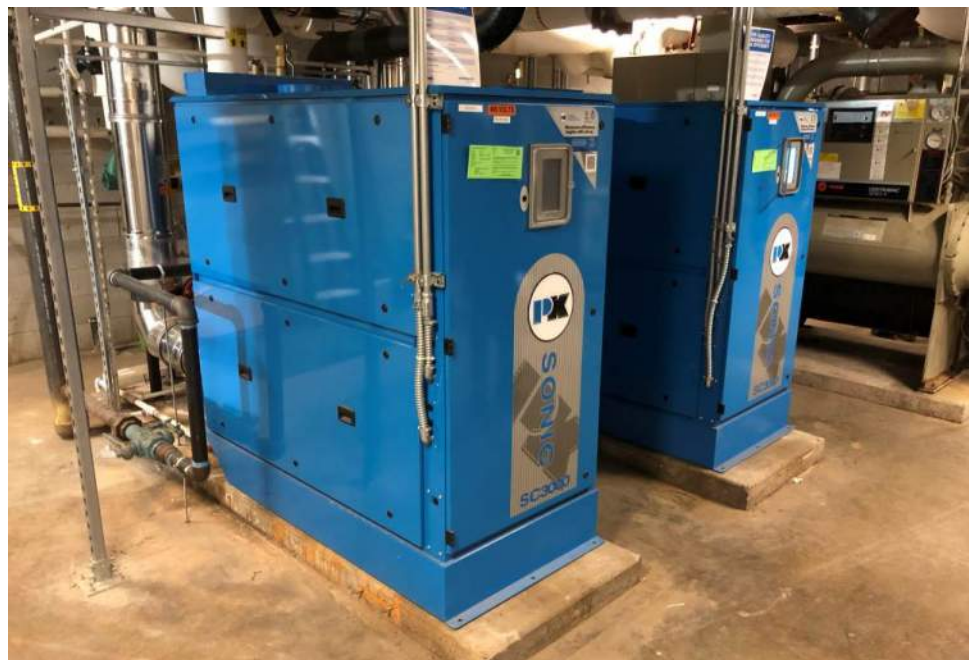
The building heating plant consists of (2) 3,000 MBH gas fired, stainless steel, condensing hot water boilers. Both boilers are of the same age and manufacturer – Patterson-Kelley “PK” model SC-3000, installed within the last few years. The boilers are in excellent operating condition and could be re-used for the next 20-30 years. These boilers can achieve combustion efficiencies of 95% or more, however this requires operating the hot water loop at lower temperatures than is typical for a building of this age. Typical hot water return temperatures are 150°F-160°F. Peak efficiency for condensing boilers is achieved at 90°F -120°F return water temperatures. The boiler flues remain separate for each boiler, and exit the building via double-wall stainless flue pipes that run up inside the former breaching from the old boilers out through the roof. Intake air is provided into the space and indirectly to the boilers through a wall louver. Boiler operation and staging is controlled through on-board packaged boiler controls.

Recently installed Patterson-Kelley gas-fired condensing boilers in excellent operating condition.

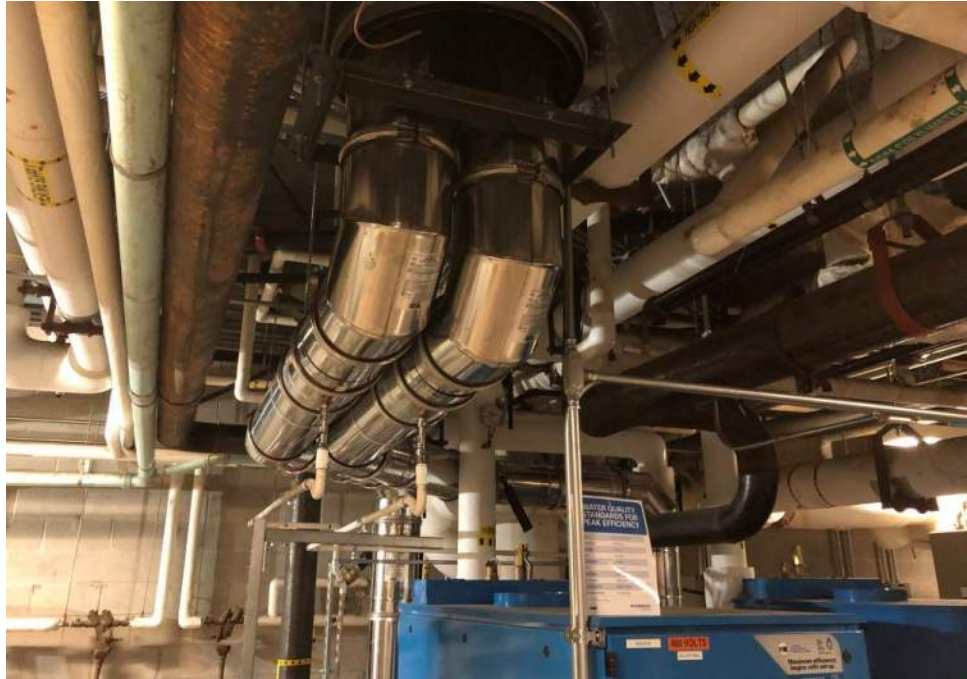
Stainless steel double wall independent boiler flues going up to the roof inside the existing boiler breaching.

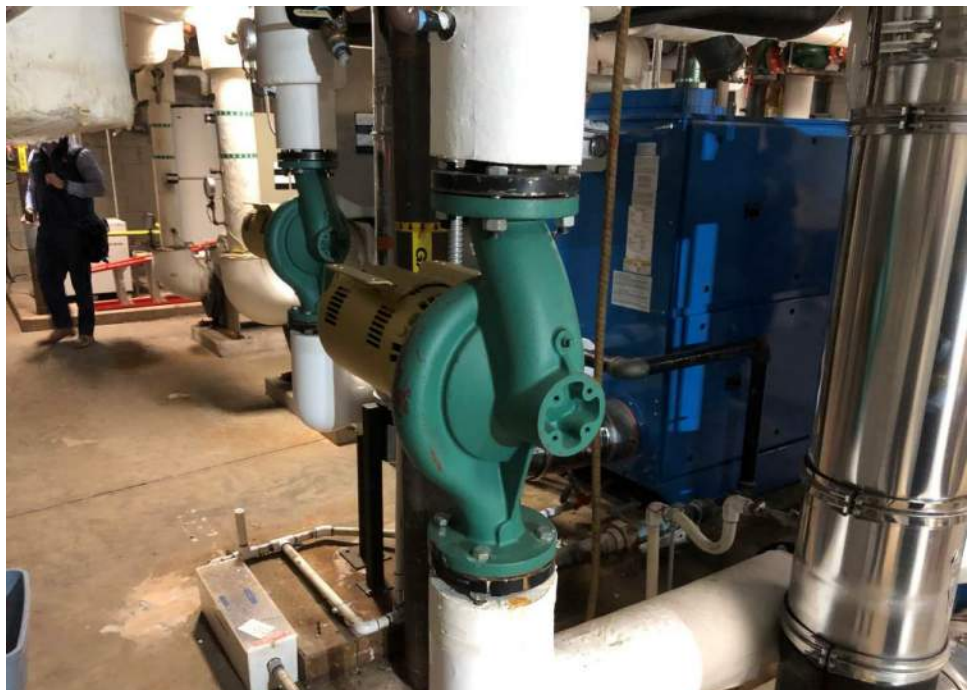
A Primary/Secondary pump system circulates hot water throughout the school at 180°F. Dedicated primary pumps for each boiler appear to be in good condition. Secondary pumps appear older and in fair condition.

Boiler primary pumps in good condition.

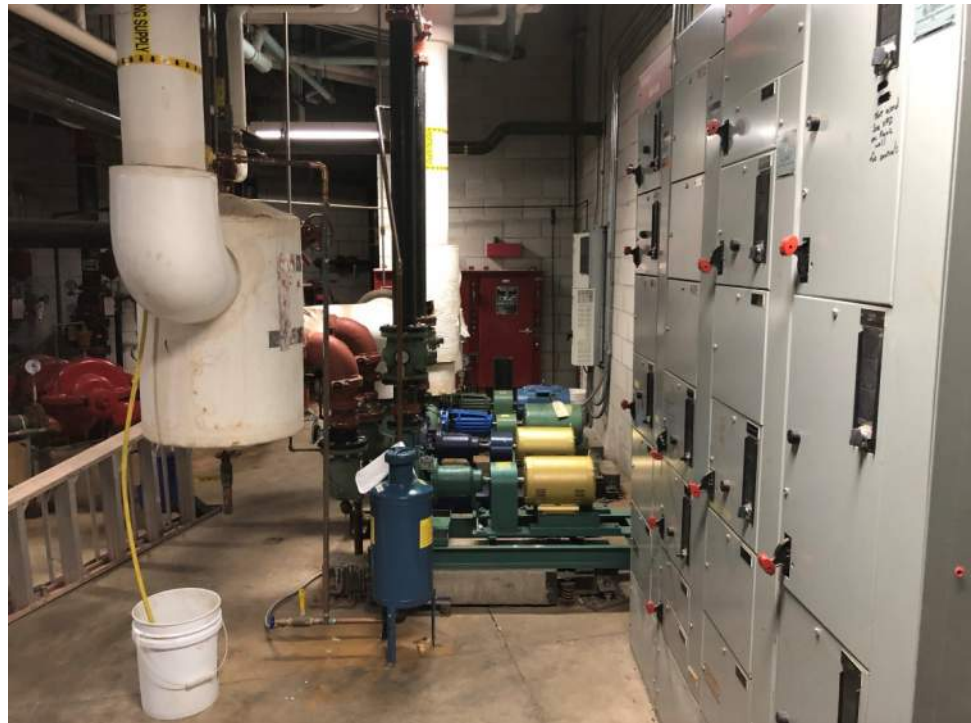
Heating hot water secondary pumps in fair condition.

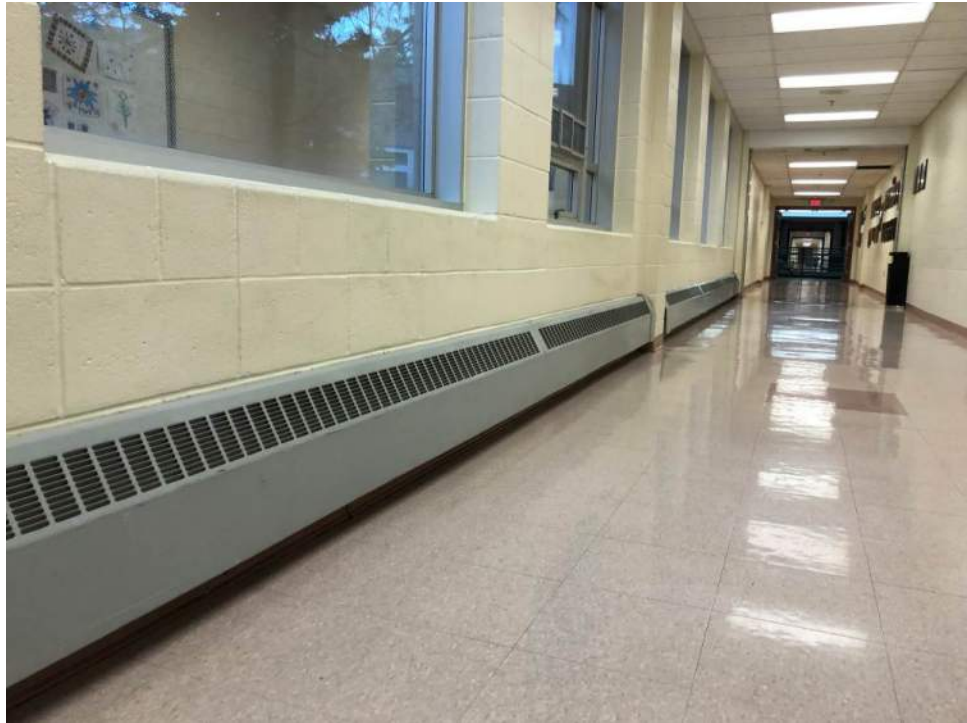
Perimeter radiation throughout appears to be in fair to good condition.

Example of perimeter fin-tube radiation in a corridor in fair to good condition.

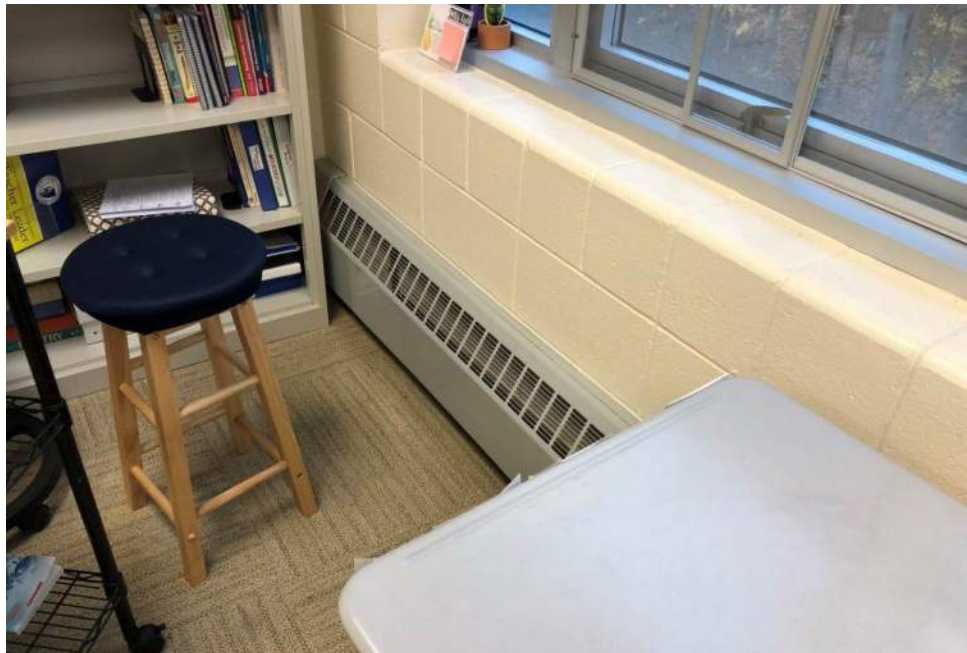
Example of perimeter fin-tube radiation in a classroom in fair to good condition.

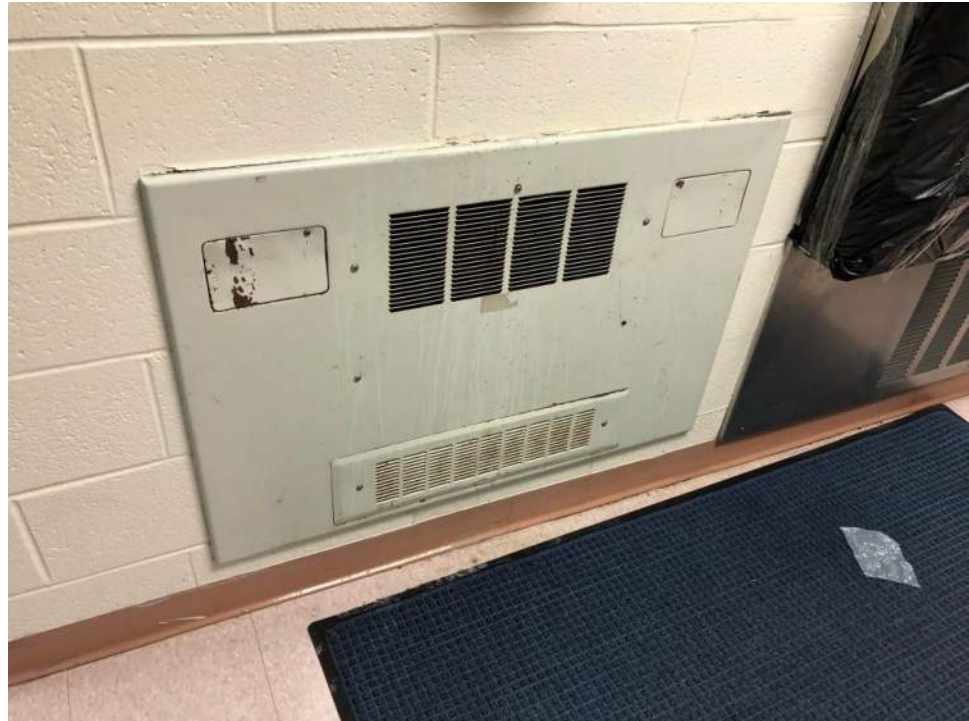
Cabinet unit heaters vary in condition, but most are in fair condition showing wear associated with being in heavily trafficked entry areas.

Example of cabinet unit heater in fair condition, showing wear and tear.

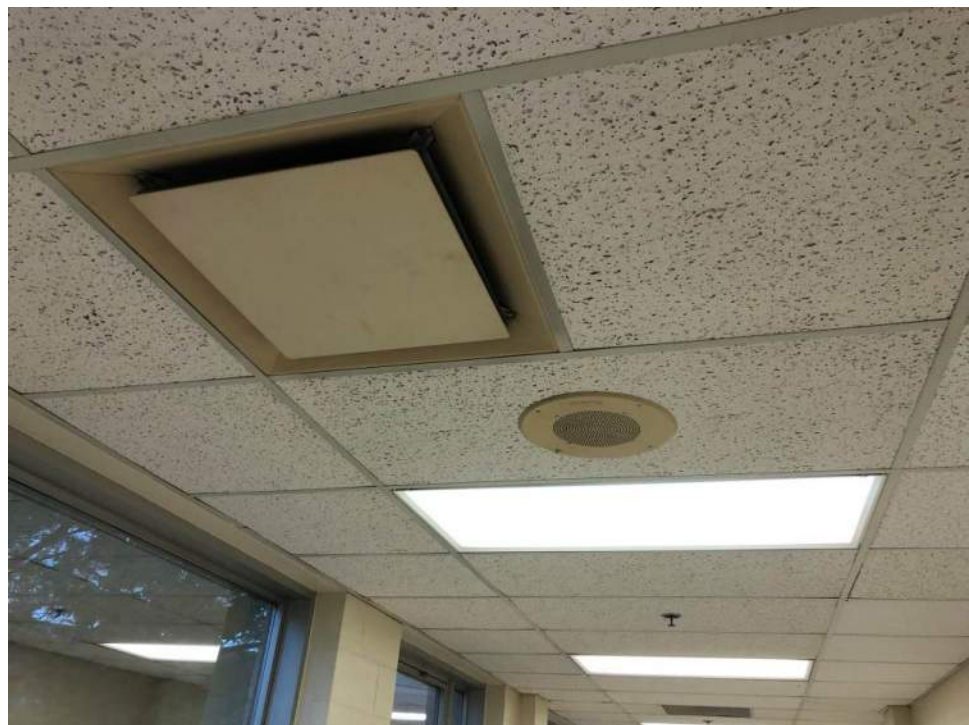
Ductwork, diffusers and grilles throughout the building are original to the building and appear dated where they can be seen. Modern HVAC systems typically do not require as large of ductwork systems as exists currently in this building, so removing the existing ductwork is a likely outcome if the building is renovated to be re-used.

Example of dated-looking supply diffuser.

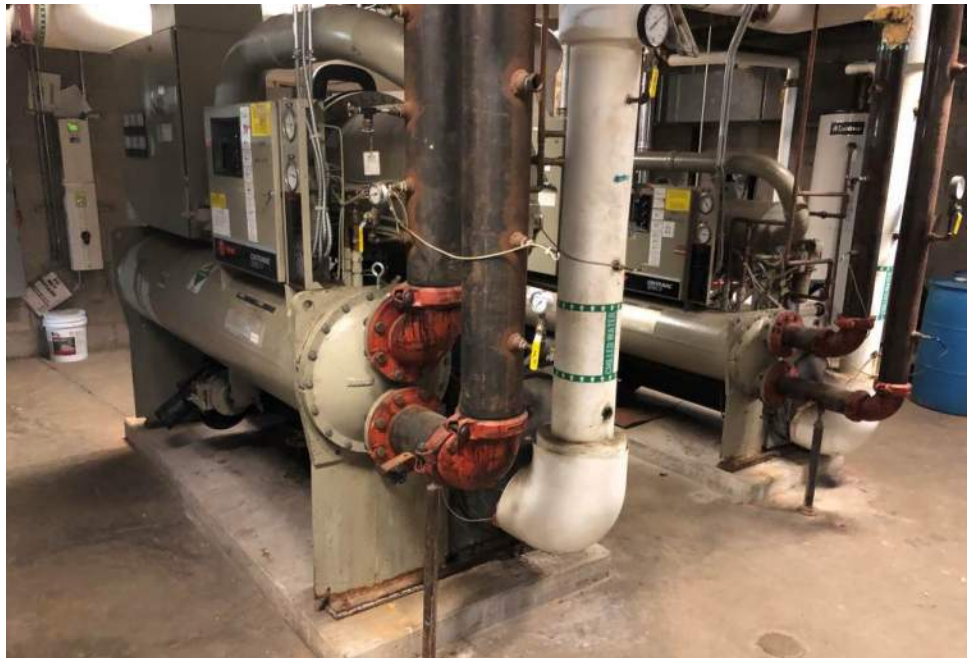
Cooling is provided to the entire building, except the gyms and locker rooms, by a central water cooled chiller plant. The plant consists of a pair of indoor Trane Centravac Series R screw chillers coupled to an outdoor cooling tower mounted at grade. One chiller is 300-tons, the other is 150-tons. The chillers are original to the building and are at or past the end of their useful life. The cooling tower is also at or past the end of its useful life. The entire chiller plant, including the associated pumps and piping, should be replaced if the building is going to be renovated.

Existing 300-ton and 150-ton Trane screw chillers, at or past their useful life.

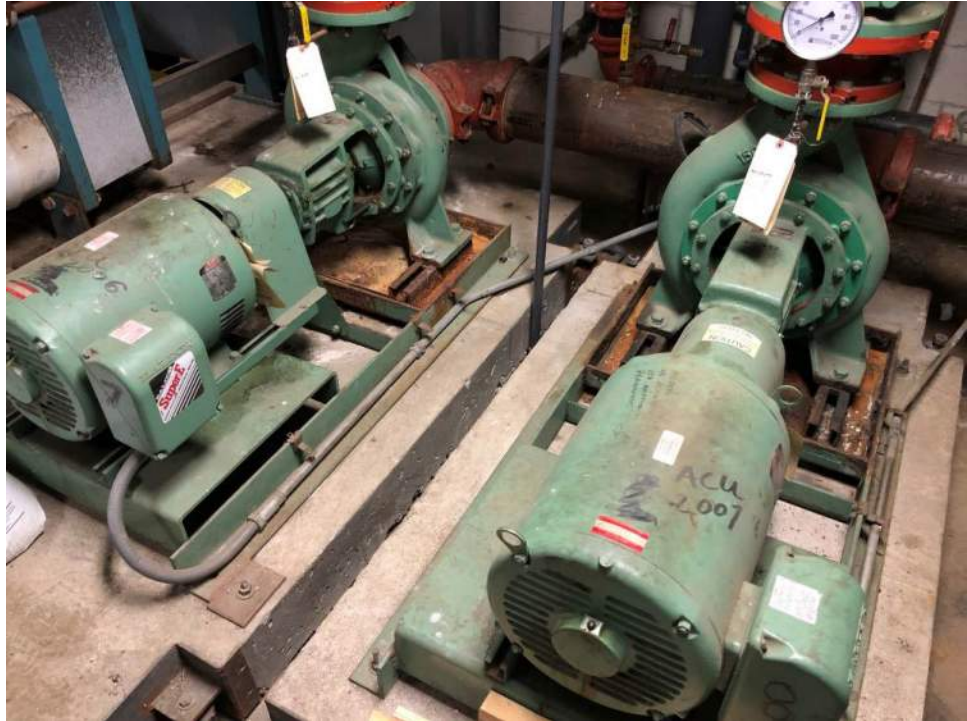
Existing condenser water pumps, at or past their useful life.

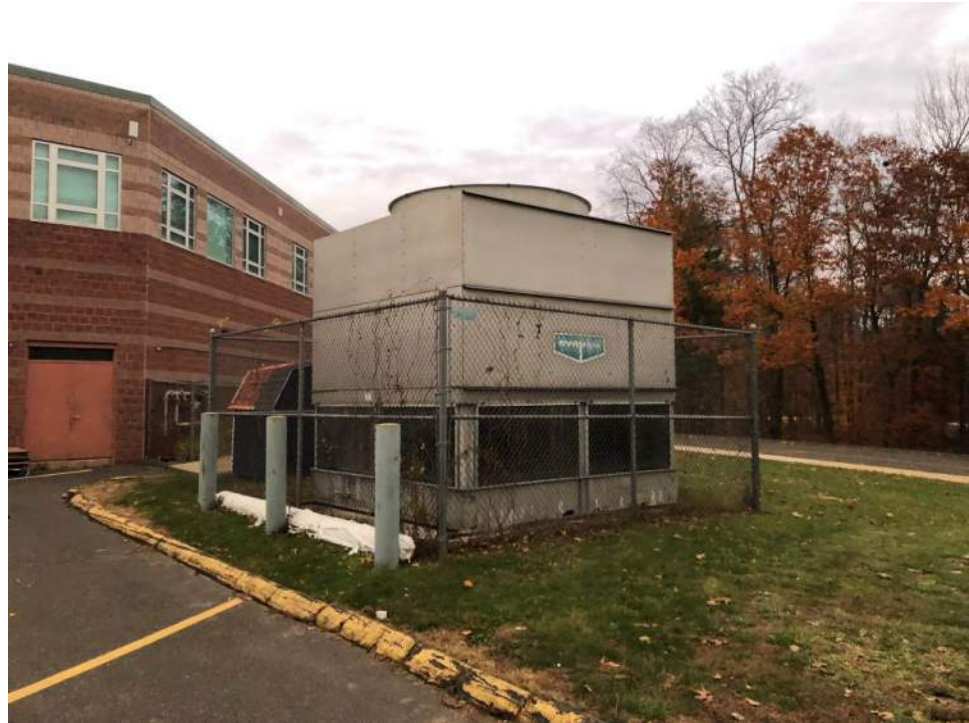
Existing Evapco cooling tower at or past its useful life.

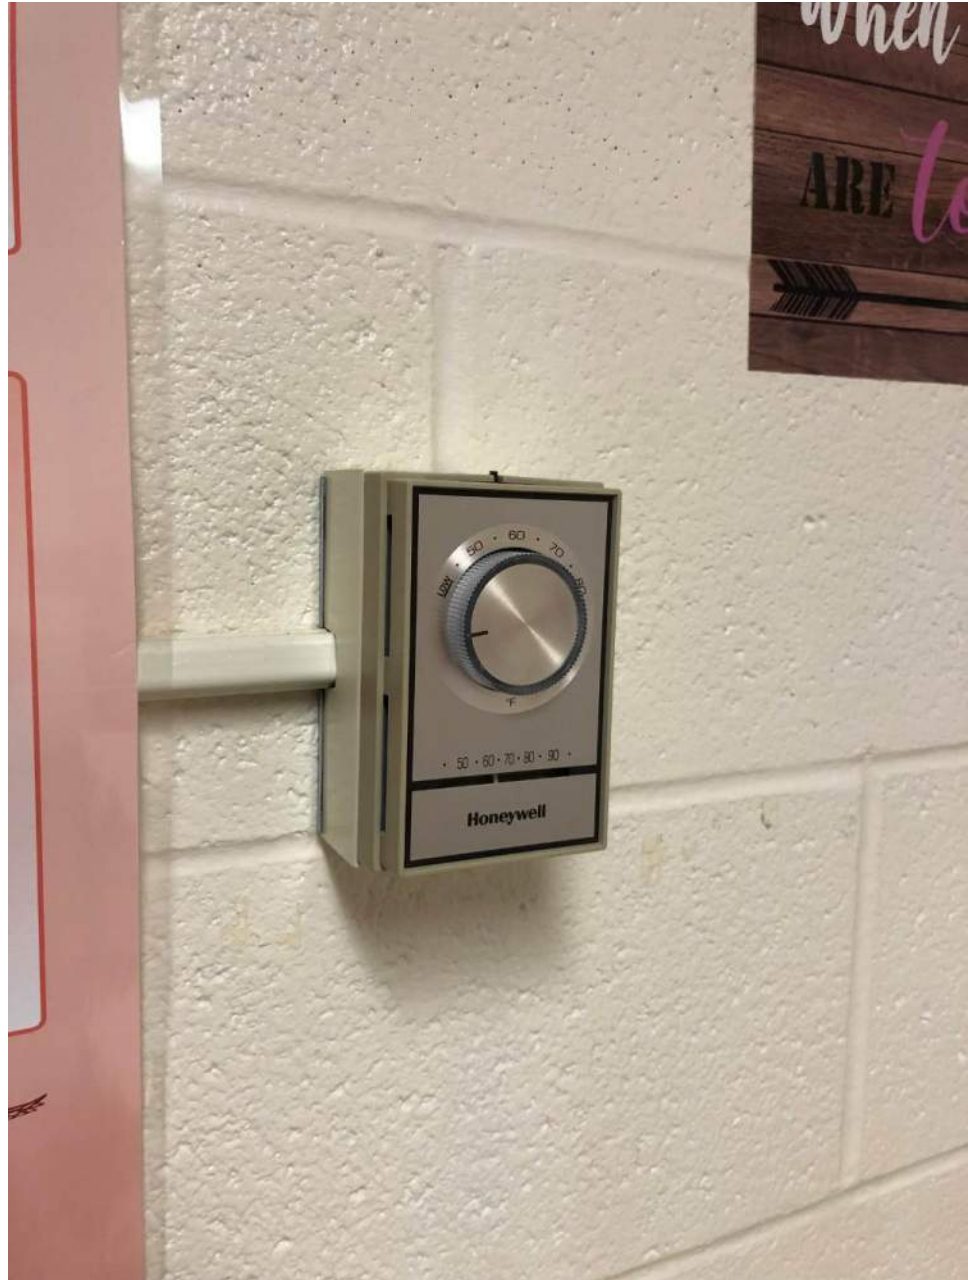
The temperature control system is original to the building and is dated. The control system should be replaced in its entirety if the building will be renovated.

Example of existing outdated thermostat.

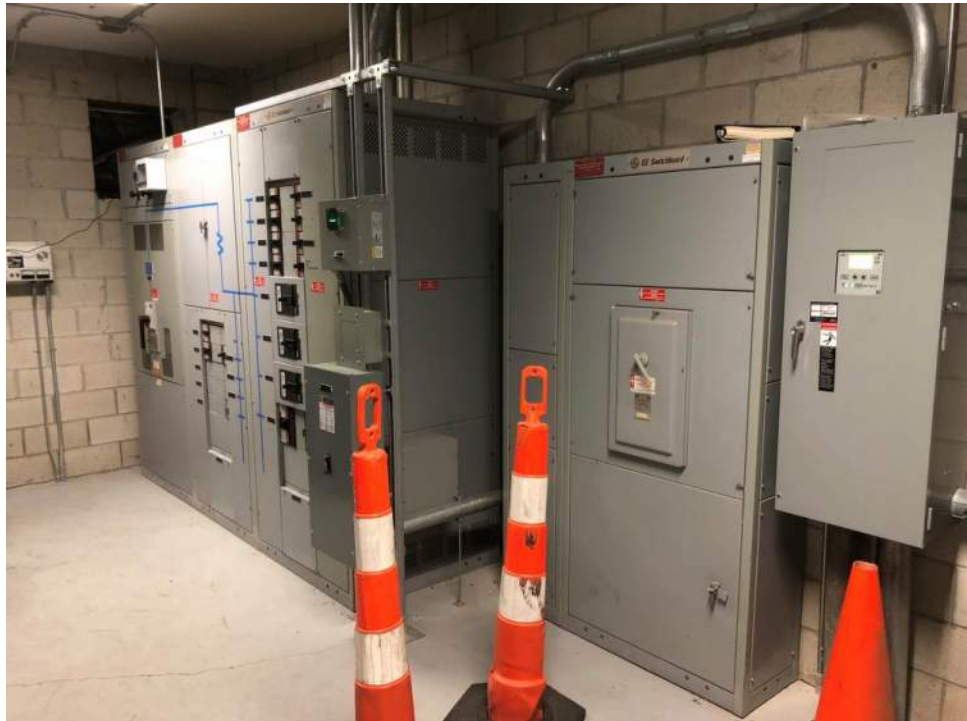
The Main Service Switchgear is rated at 3000A, 480/277V, 3-phase, 4-wire and is manufactured by General Electric. It appears to be original to the building and is in fair condition. All of the main distribution equipment is now more than 30 years old. As such, it is nearing the end of its serviceable life and should be replaced.

Main switchgear, original to building and near the end of its useful life.

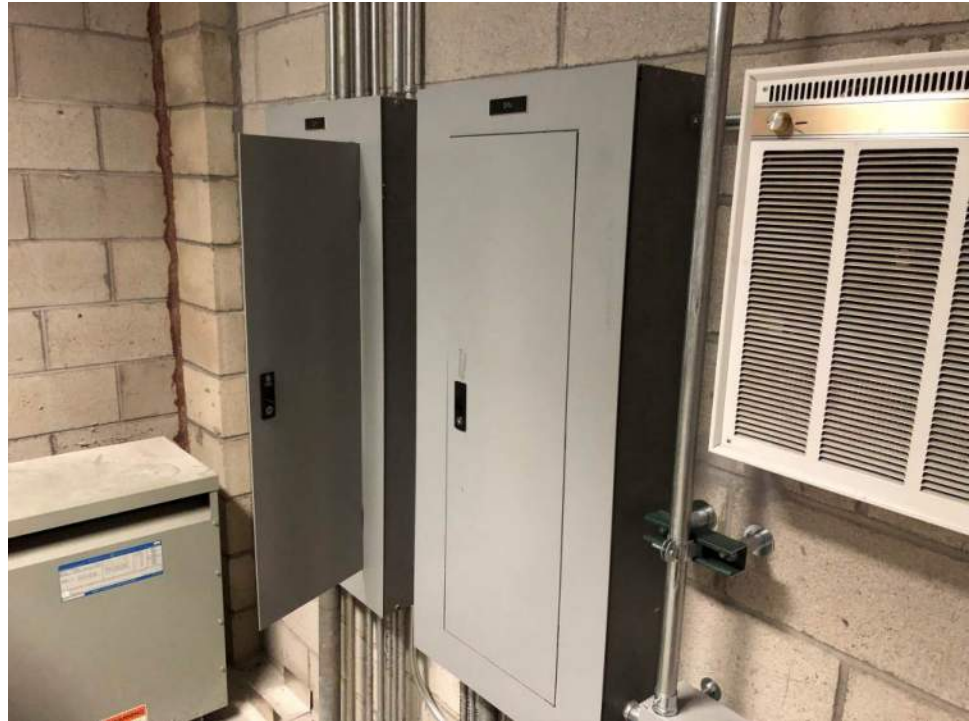
Existing electrical distribution panelboards.

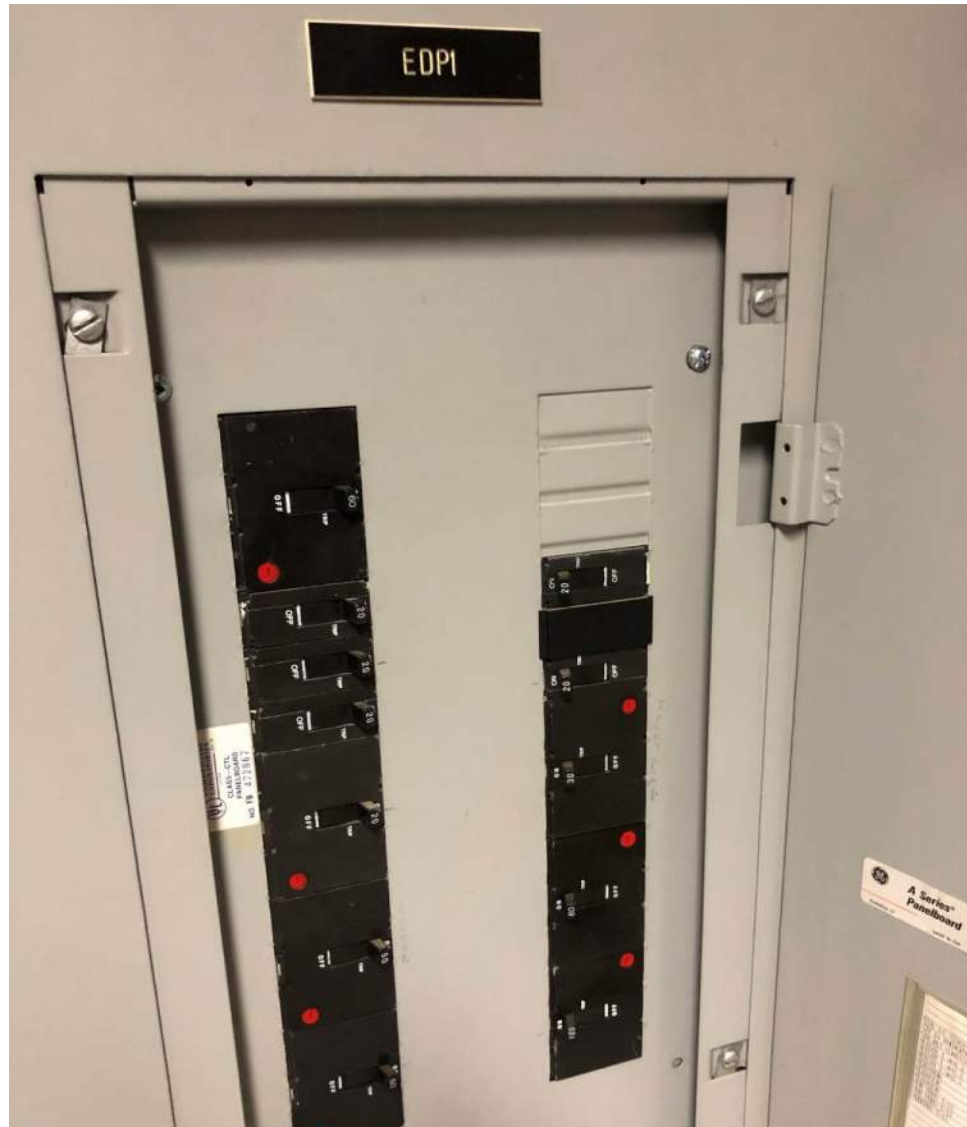
Circuit breakers Inside an existing electrical distribution panelboard.

Most of the electrical equipment (branch panelboards, disconnect switches, motor starters, etc.) appears to be original to the building. Branch panelboards are manufactured by General Electric and are of the molded case circuit breaker type. Disconnect switches, motor starters, etc. are mainly by General Electric. All of the equipment that was observed is more than 30 years old and is nearing the end of its useful life.

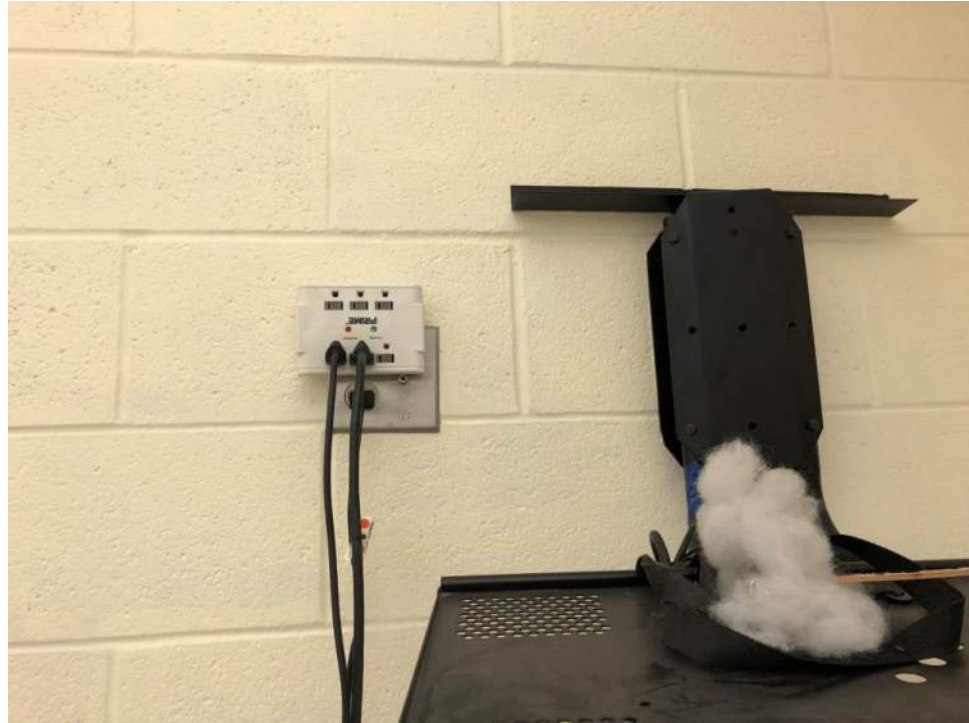
Receptacles in the building were mostly observed to be the 3-prong type. GFCI receptacles were observed near sinks and in other areas as required.

Example of existing power receptacle.

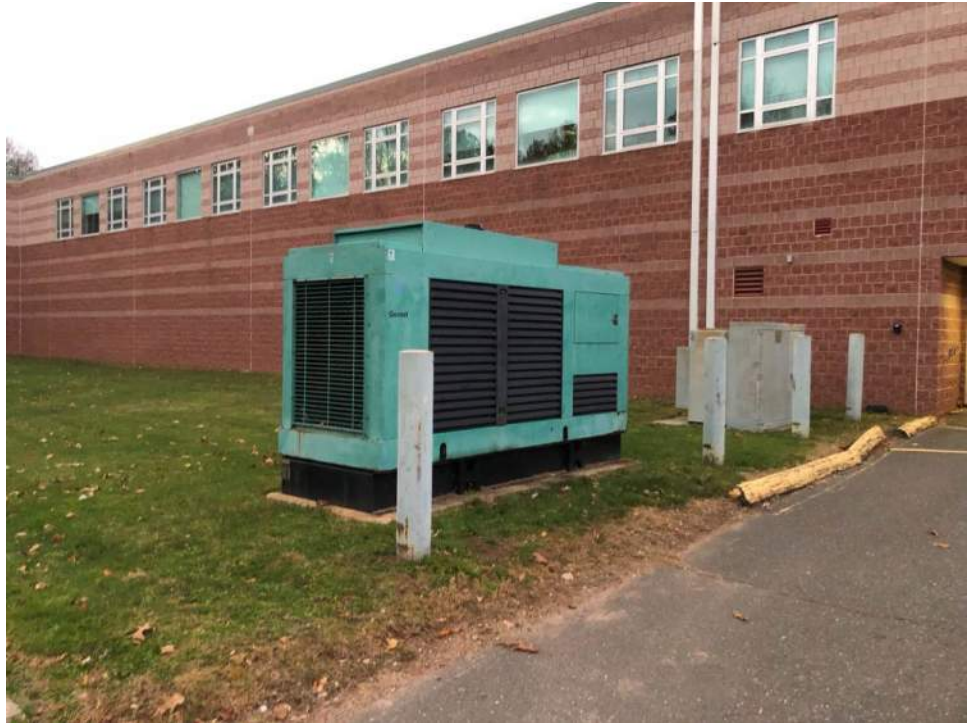
Emergency/optional standby power is provided by a Cummins diesel generator-set located at grade outside the back of the building, next to the cooling tower. This generator is fed by a diesel “belly tank” that the generator is mounted on top of. Emergency power is routed inside to the existing fire pump as well as to an emergency automatic transfer switch serving emergency lighting and fire alarm as well as optional standby loads. The generator appears to be original to the building, so is nearing the end of its useful life.

Diesel generator with belly tank.

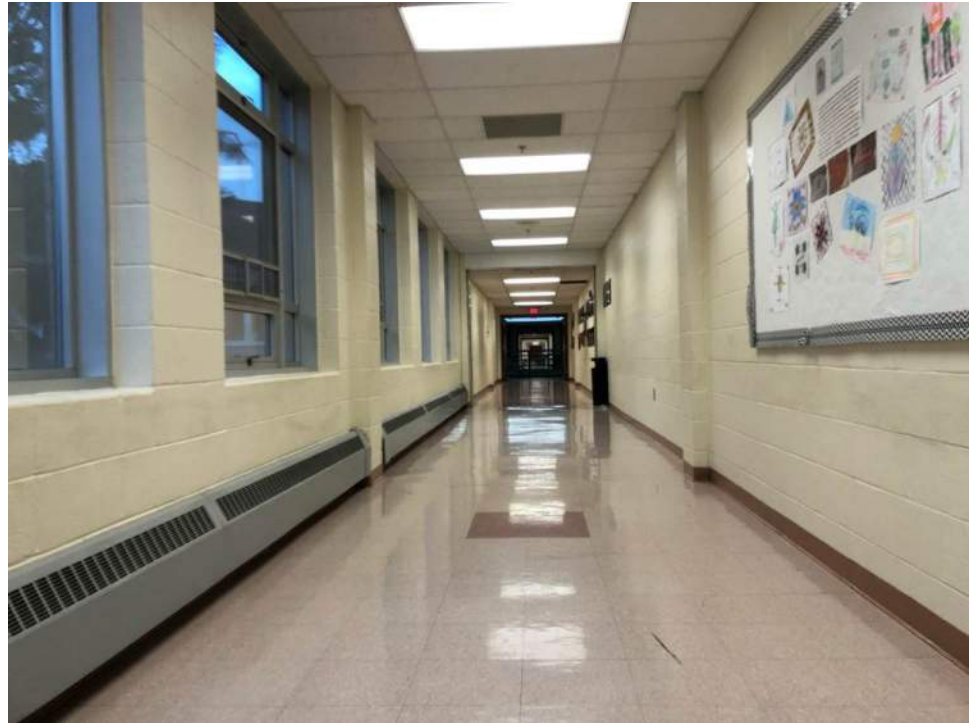
Example of corridor 2 x 4 fluorescent lighting.

Lighting fixtures in the corridors are controlled by key operated toggle switches. Suggest replacing these with a combination of low voltage switches and lighting control relay panels. This practice follows energy code guidelines and will increase efficiency.

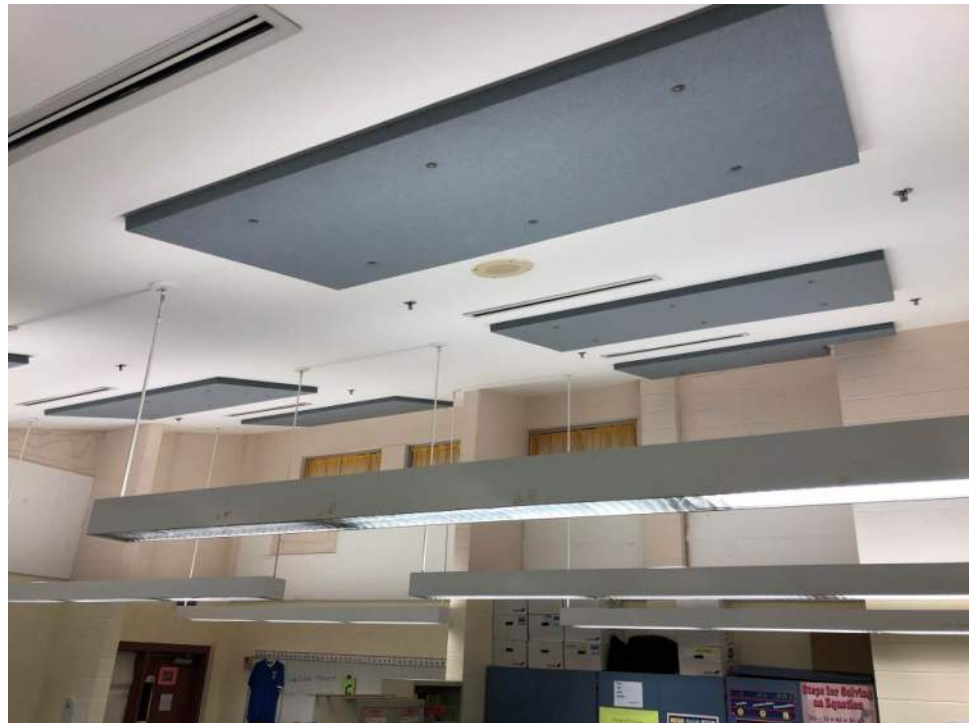
Example of classroom pendent fluorescent lighting.

CES suggests replacing the existing light fixtures in classrooms with new LED fixtures and drivers. Provide new low voltage wall dimmer switches and ceiling mounted occupancy/vacancy sensors and using daylight sensing for fixtures that are closest to windows. This practice follows energy code guidelines and will increase energy savings over the long term while providing better light quality.

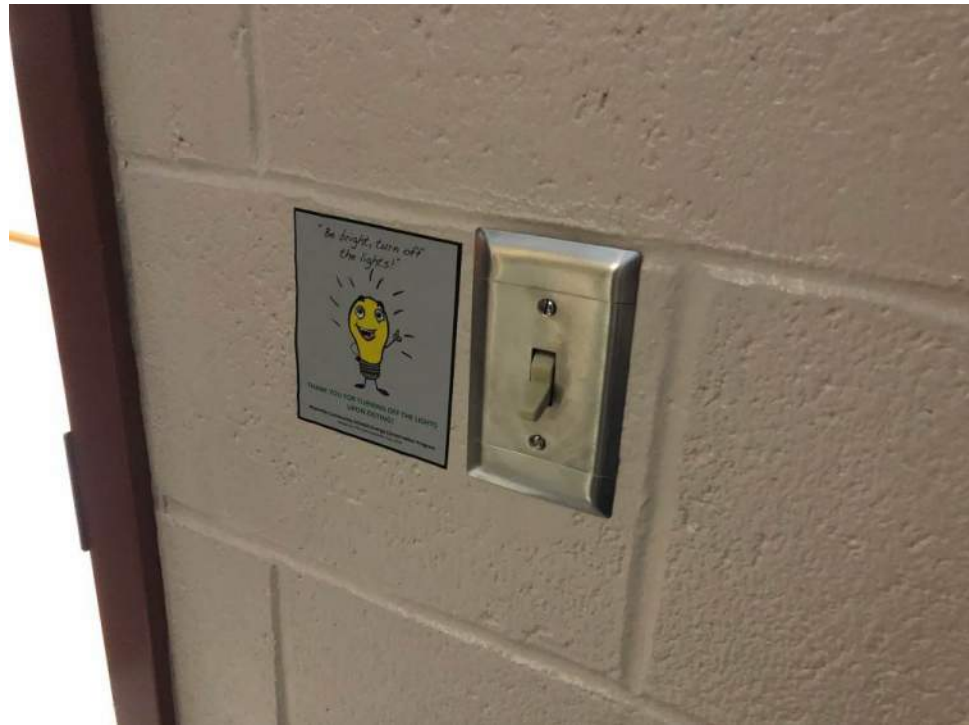
Example of manual toggle switch for lighting control.

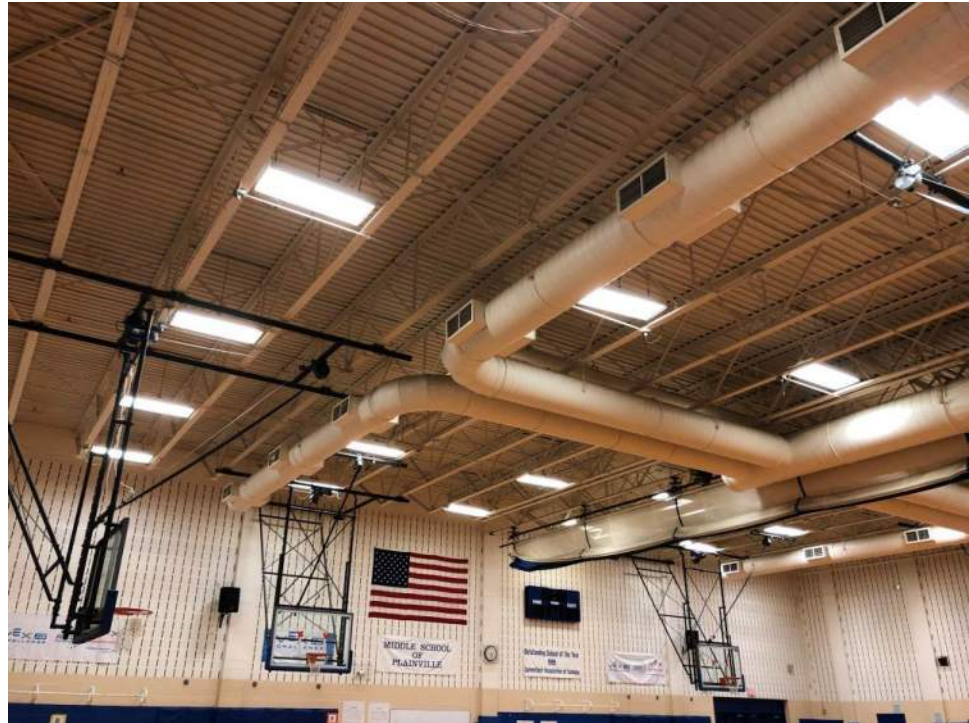
Lighting fixtures in the gymnasium are pendant mounted hi-bay HID type and appear to be in fair condition. These are controlled via a contactor. Suggest replacing the lights with hi-bay LED designed fixtures and updating the controls according to current energy code standards.

High bay gym lighting.

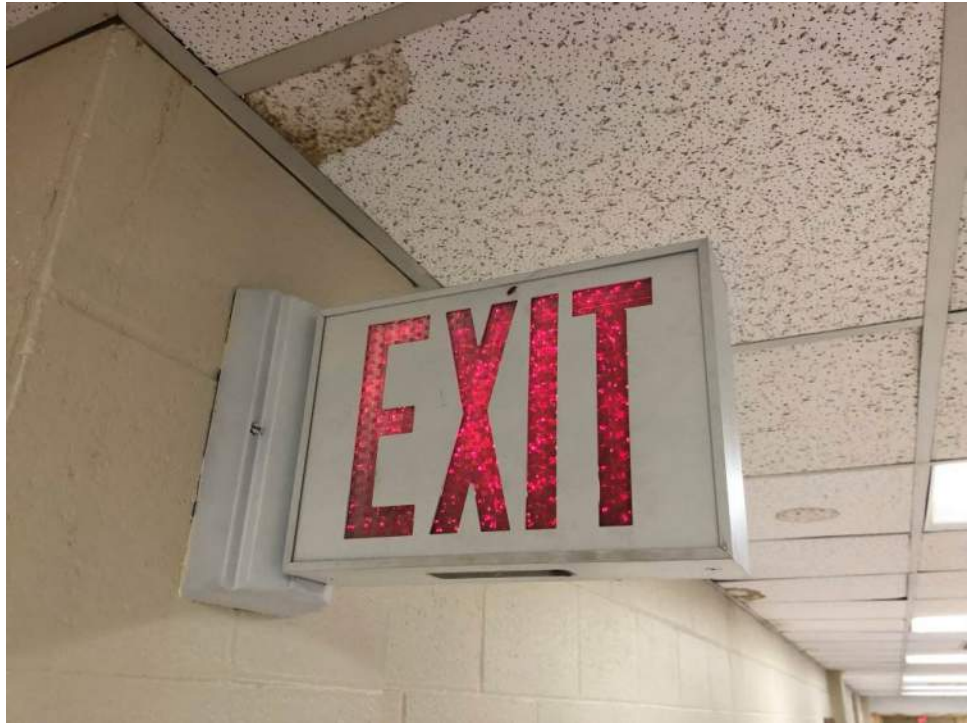
The use of exit signage in all areas of the building appears to be in compliance with current codes. Exit signs are LED with battery back-up. All signage appears to be in fair condition, but should be replaced with any major renovation.

Example of existing exit sign.

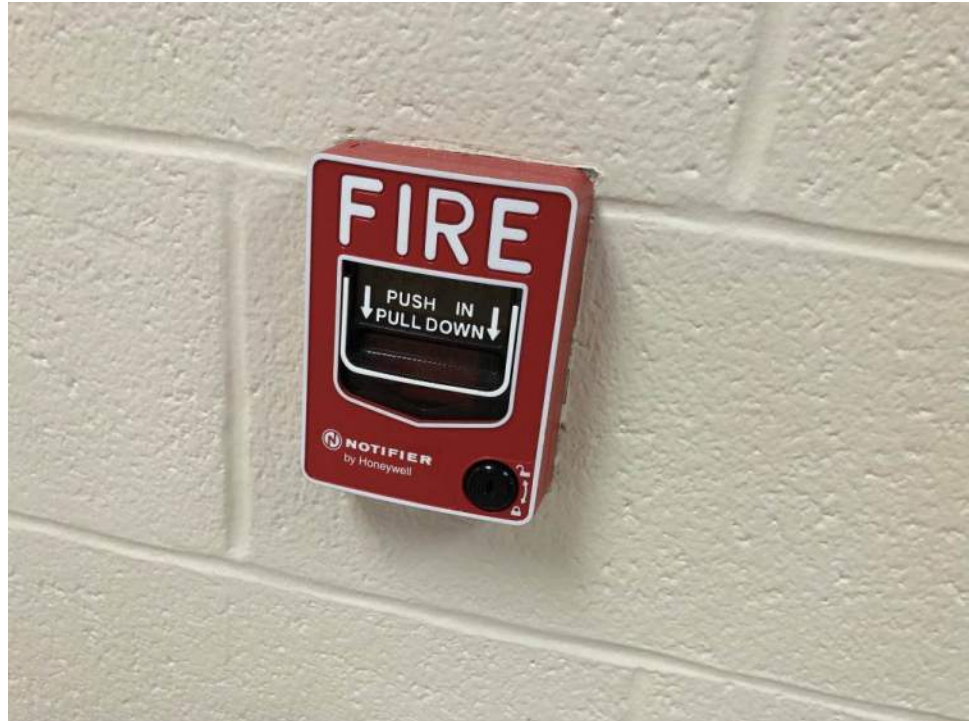
Newer fire alarm pull station.

The building is equipped with a Notifier addressable fire alarm system. Pull stations throughout appear new, while existing horn/strobes appear original to the building. Full replacement of this system is recommended as part of any major renovation.

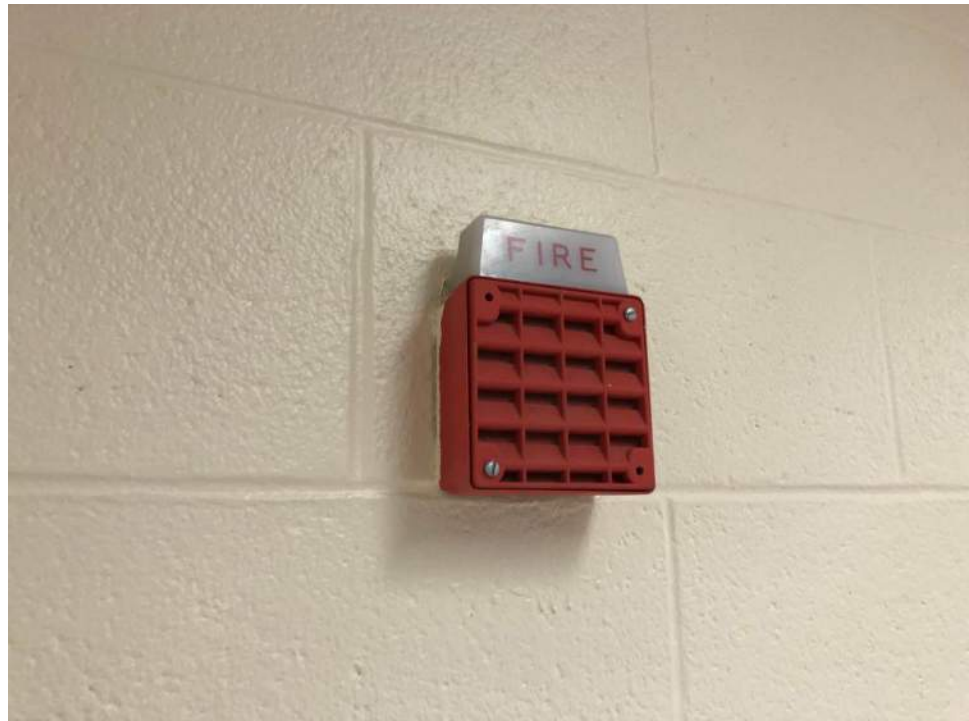
Older fire alarm horn/strobe.

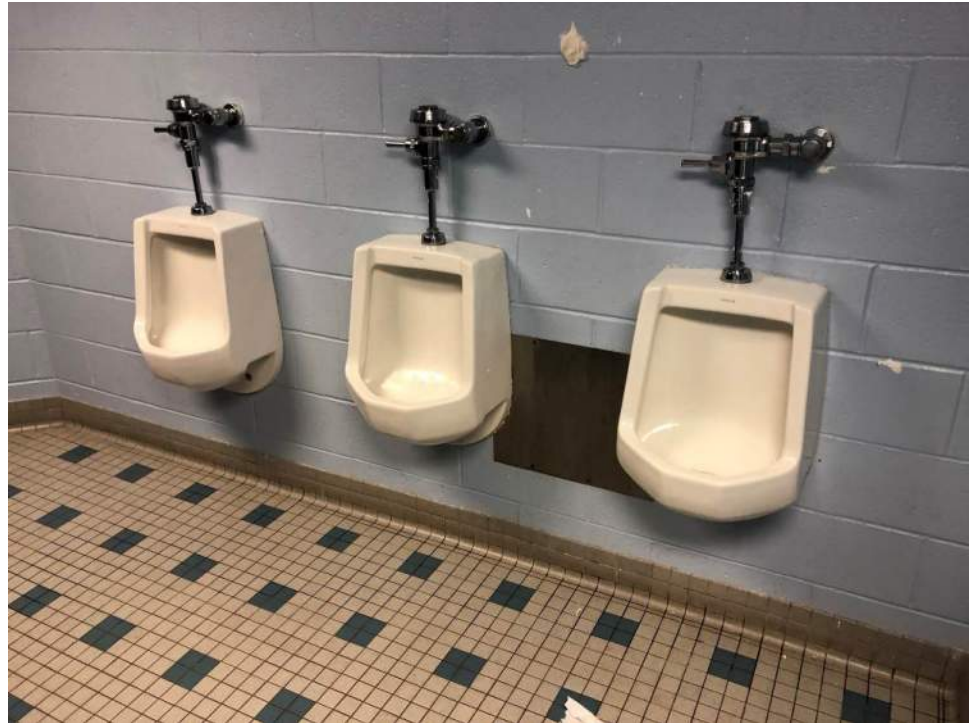
Plumbing fixtures within the building all appear to be original to the building.

Existing urinals in one of the boys bathrooms.

All plumbing fixtures should be replaced as part of any major renovation to newer more efficient units with water saving features.

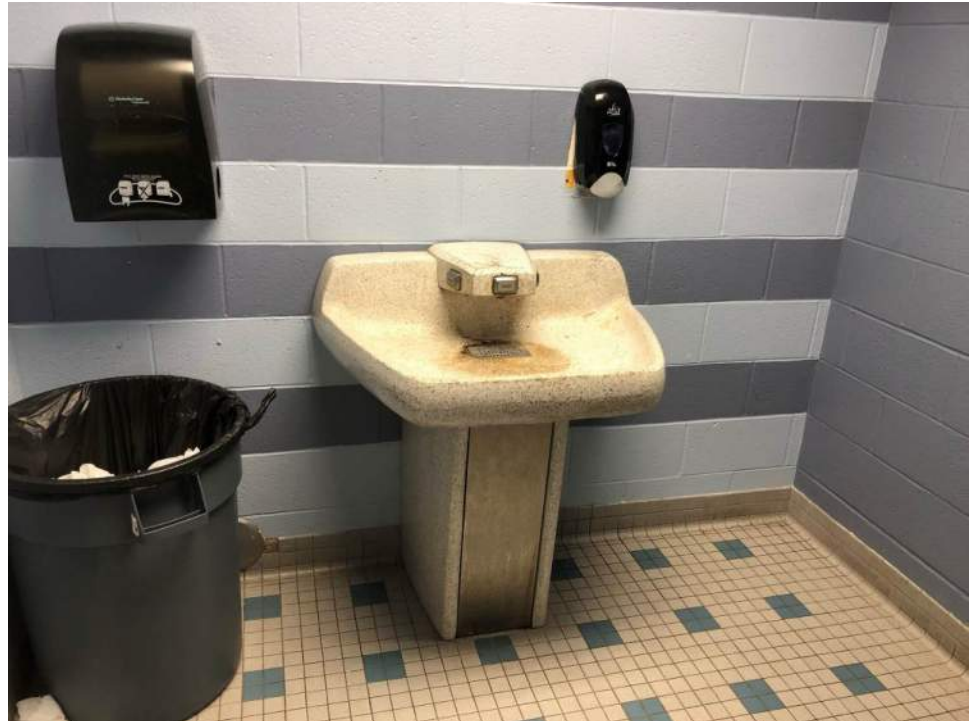
Boys and girls bathroom lavatories are the Bradley large basin type with multiple faucets. They have deteriorated in functionality over time and regularly cause problems for facilities staff.

Existing Bradley lavatory in one of the boys bathrooms.

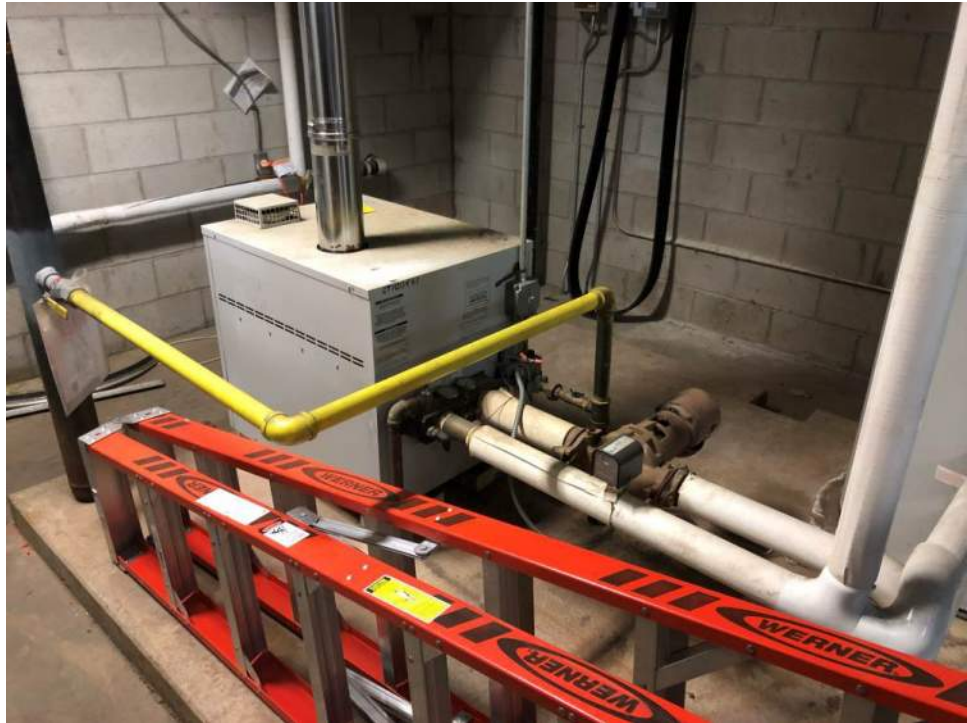
Domestic hot water is provided by a Lochinvar “Efficiency Pac” semi-instantaneous hot water heater coupled with an indirect storage tank. The heater is near the end of its useful life and should be replaced as part of any major renovation.

Lochinvar semi-instantaneous hot water heater.

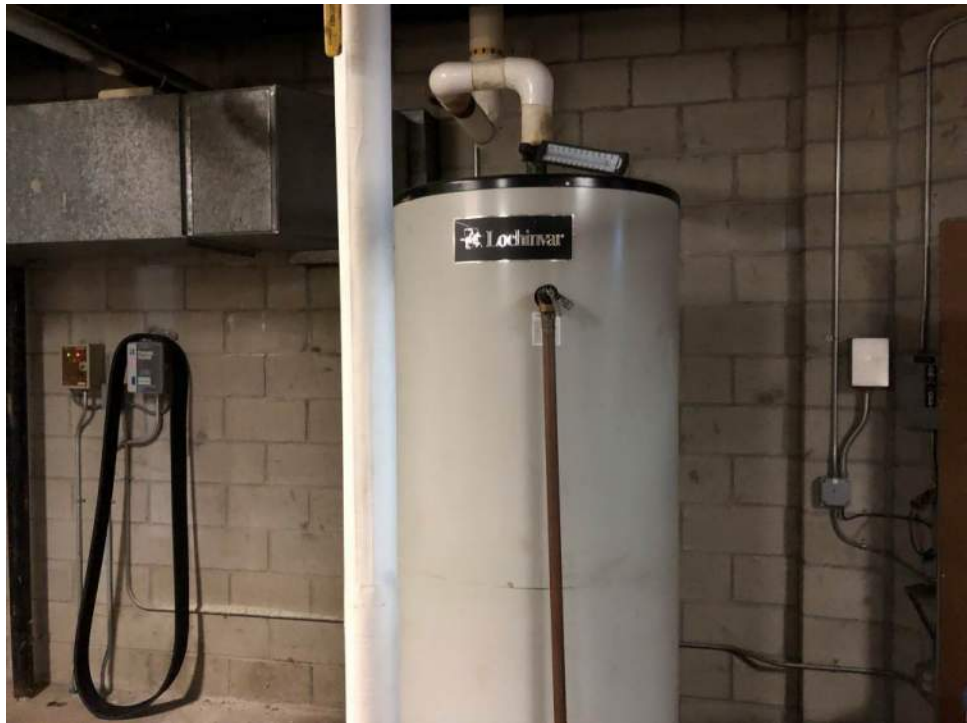
Lochinvar indirect fired storage tank.

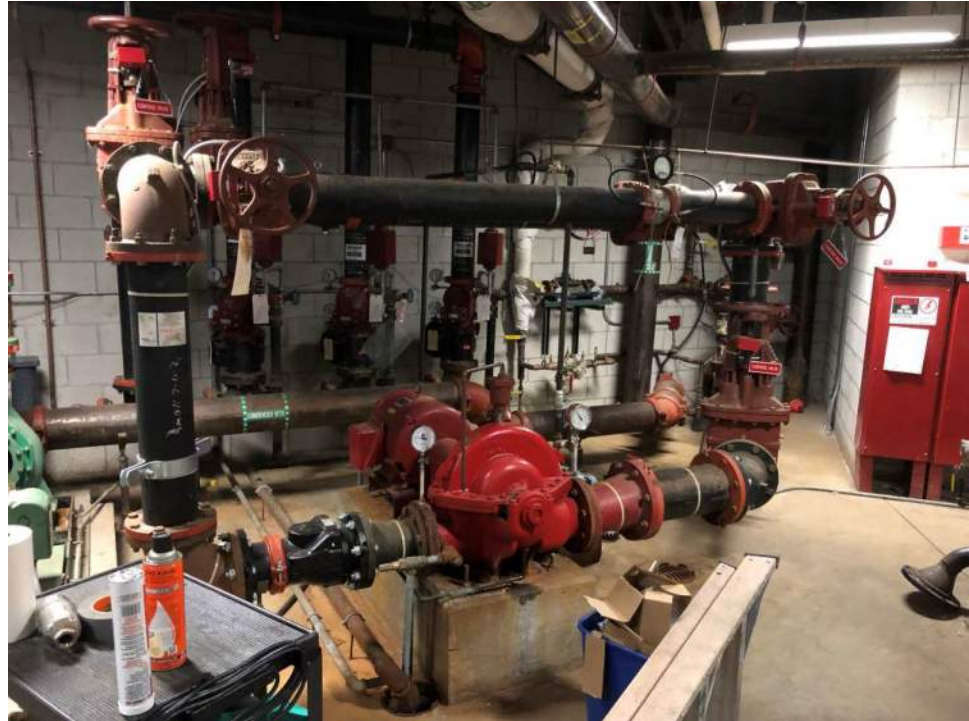
Fire service piping and horizontal electric fire pump.
