3.4 Mechanical, Electrical, Plumbing, Fire Protection Existing Conditions

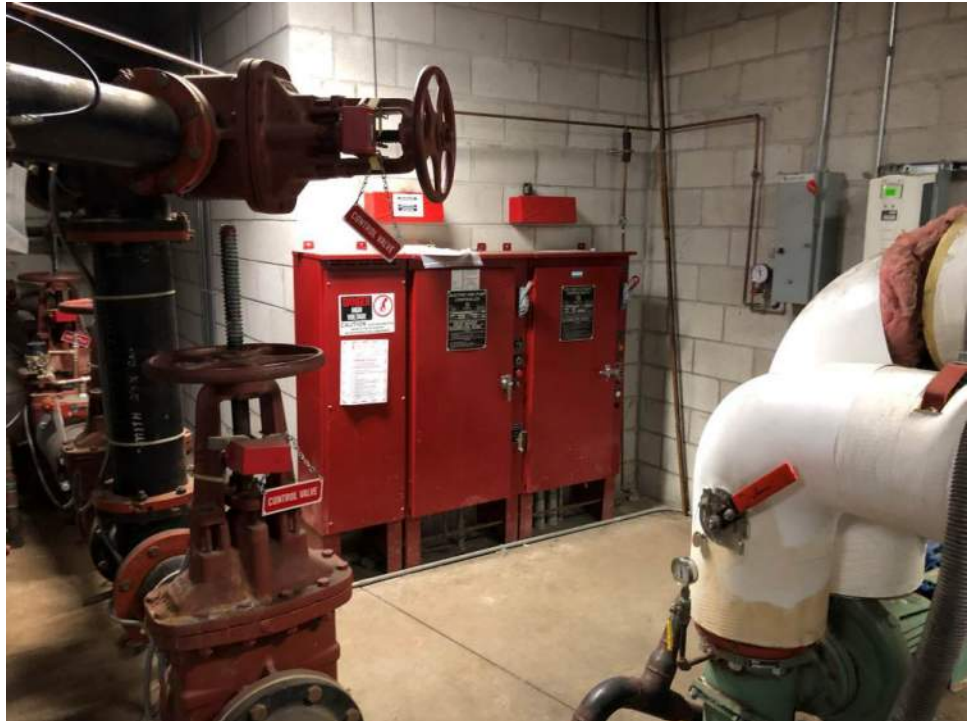
Obsolete fire pump controller.

The water pressure during original construction was low and so an electric fire pump is present to boost the pressure. Facilities staff commented that water pressure in the street has since improved, so a fire pump may no longer be necessary. The existing fire pump controller is original to the building and difficult to get parts for. Should a fire pump still be required, the pump and controller should be replaced.

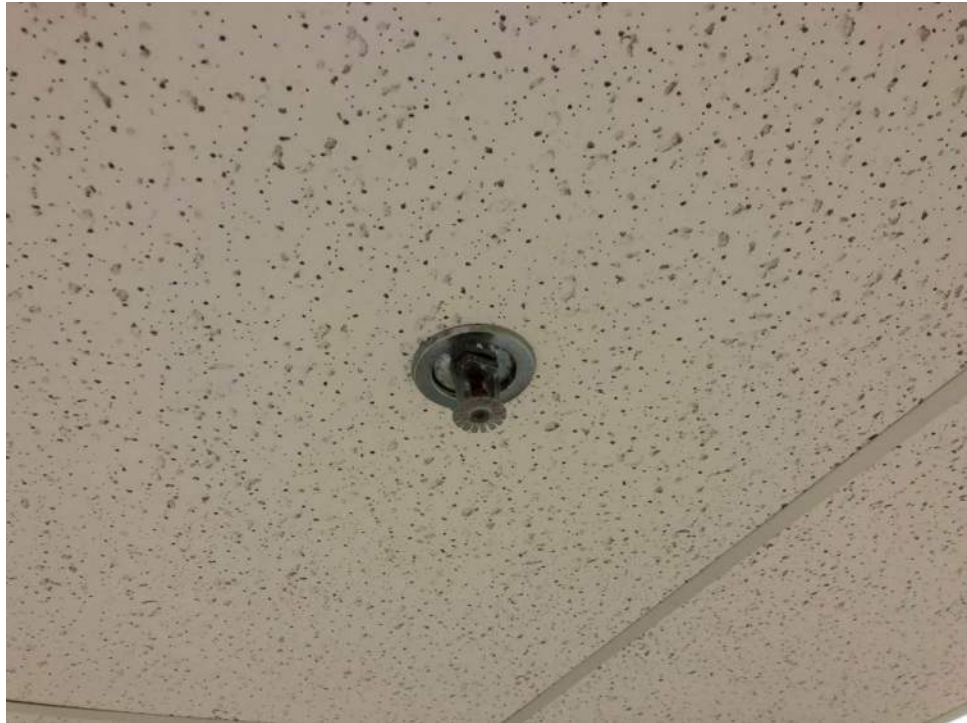
Example of pendent sprinkler head.
