# Paderewski Pond Assessment and Alternatives Analysis

Presented by:  
Loureiro Engineering Associates, Inc.  
December 5, 2016

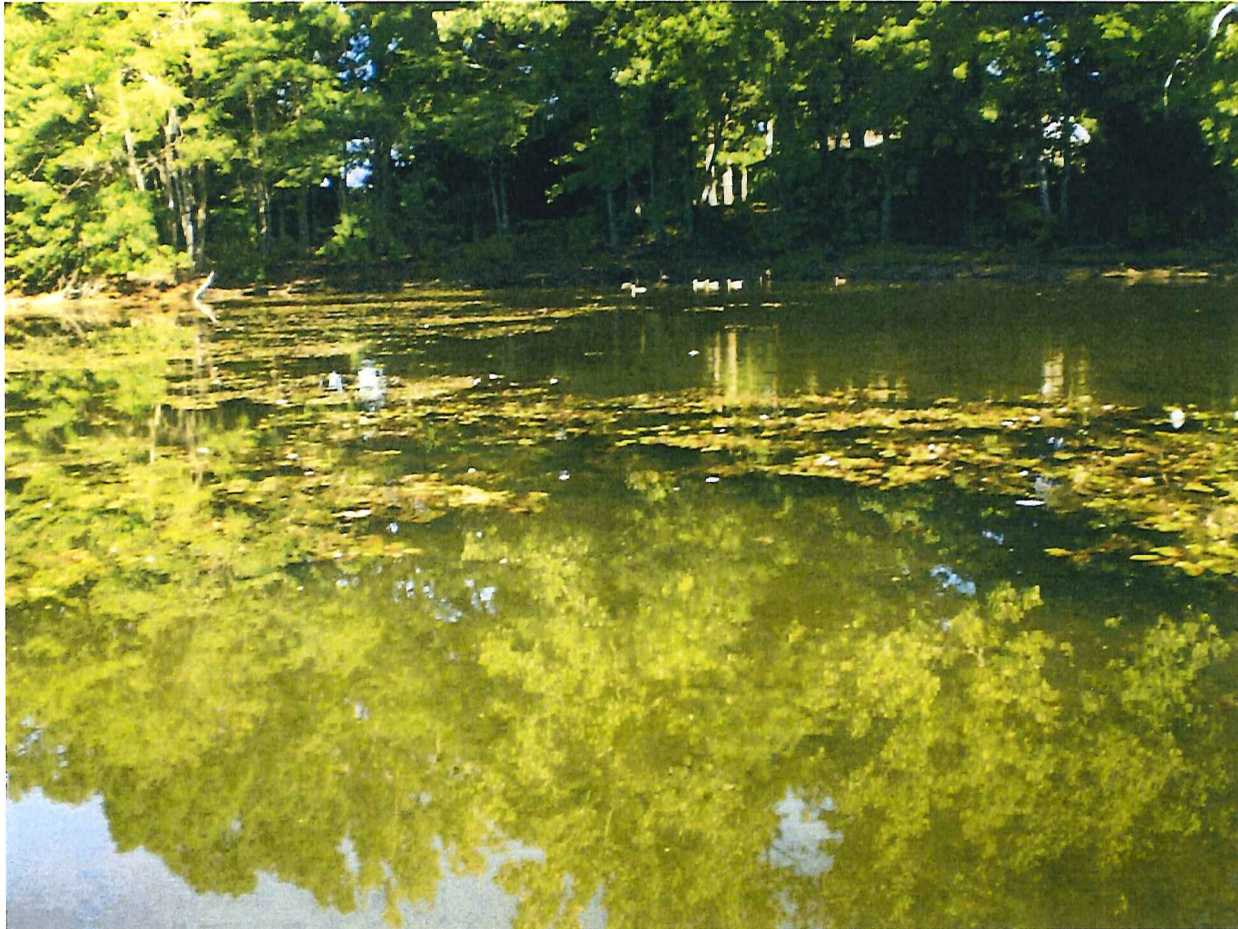
# Loureiro Observations August 23, 2016

- Paderewski Pond has significant vegetation primarily *Elodea nuttallii* (waterweed).
- Matting of the surface was observed on August 23, 2016 thereby reducing sunlight to the lower depths of water.
- This reduces photosynthesis (oxygen production) and enhances respiration (oxygen consumption).
