Paderewski Pond Assessment and Alternatives Analysis

Paderewski Pond Plainville, Connecticut

November 2016

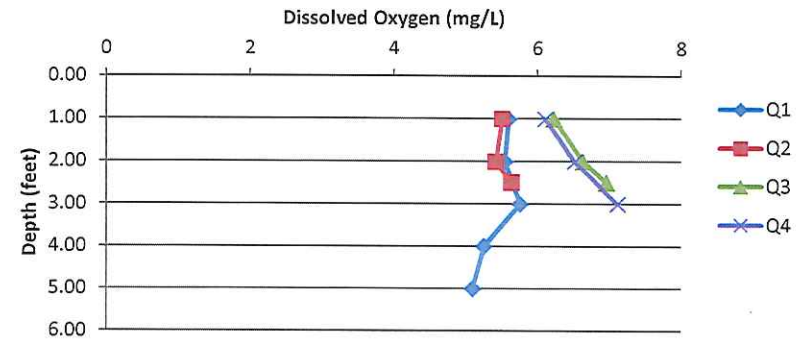
DO Readings

A difference of 1 degree Celsius can indicate a stratified pond. Quadrants 1, 2, and 4 did not vary greatly in temperature throughout the water column. Quadrant 3 varied slightly in temperature; however, DO levels did not suggest such a condition.

The majority of the data fell within the healthy pond range. DO is the most critical indicator of pond health and should range between 6-10 mg/L with a minimum required concentration of 5 mg/L to maintain a healthy fisheries program. The DO levels observed in Paderewski Pond were slightly below the optimal range but were still measured above the 5 mg/L.

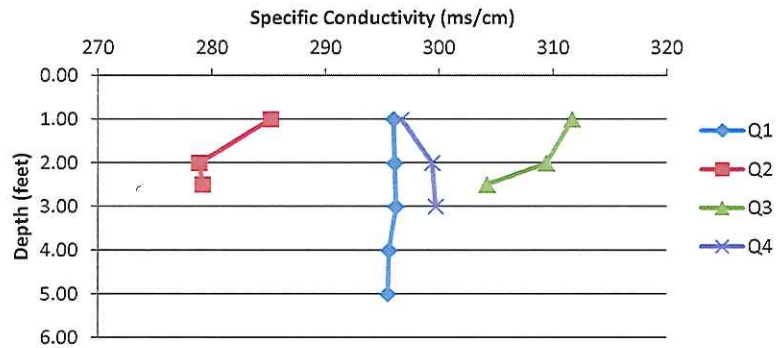
Specific Conductivity Readings

Specific conductivity and pH readings did not follow a trend within the water column. Specific conductivity values ranged from 278.9 ms/cm to 311.7 ms/cm which is well within the

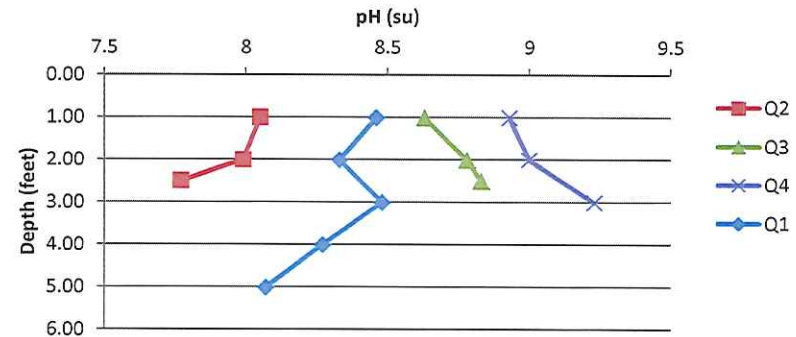
pH Readings

acceptable limit for a healthy pond. The pH readings ranged from 7.77 to 9.23. The average pH value throughout the pond was 8.48 which is on the high end of the acceptable range for a healthy pond which is between 6.0 and 9.0. The DO, pH, specific conductivity, and temperature profiles are included at Attachment C.

The ideal pH range for supporting freshwater aquatic life is 6.0 to 9.0. Laboratory and field pH values were slightly high but not of significance since most species can tolerate pH levels outside of the ideal range.

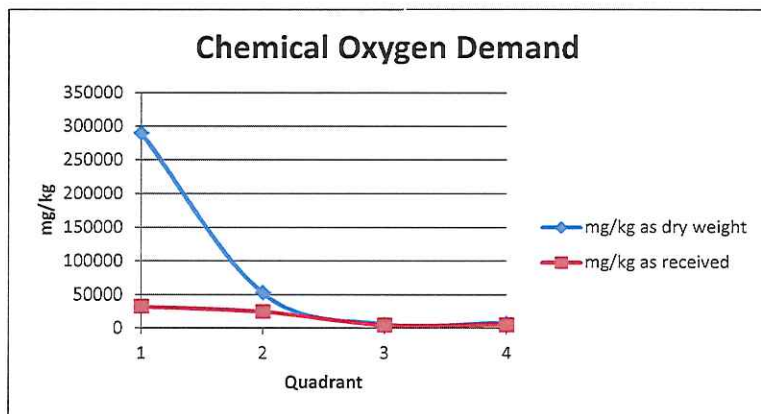
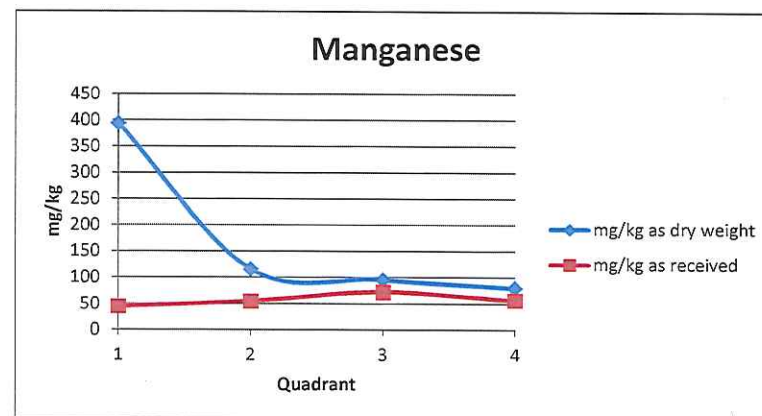
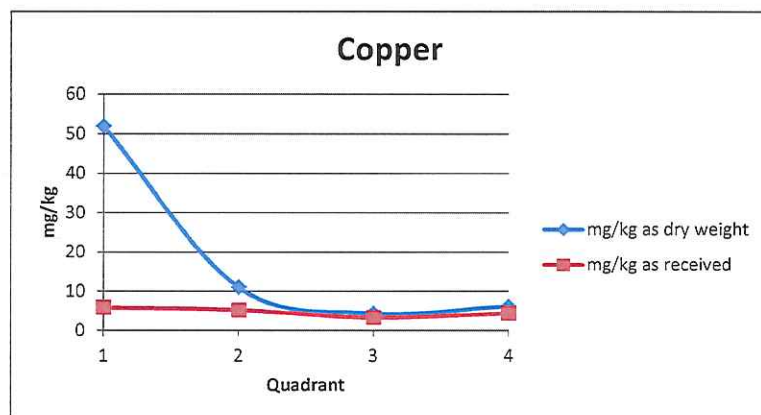
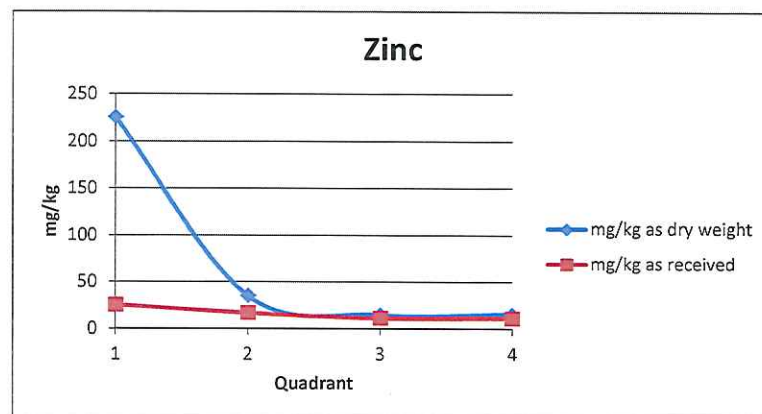
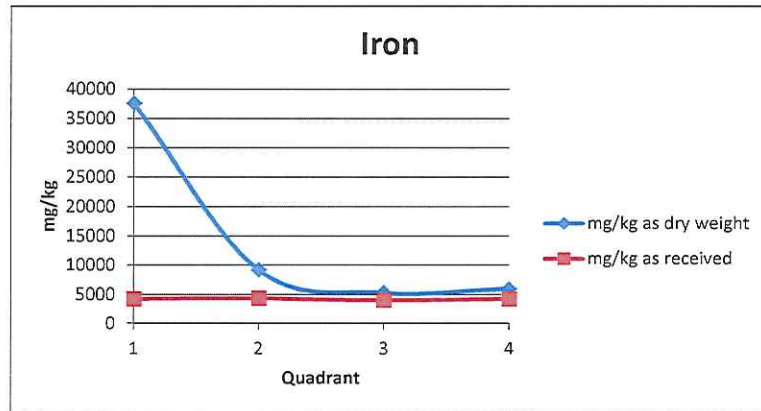
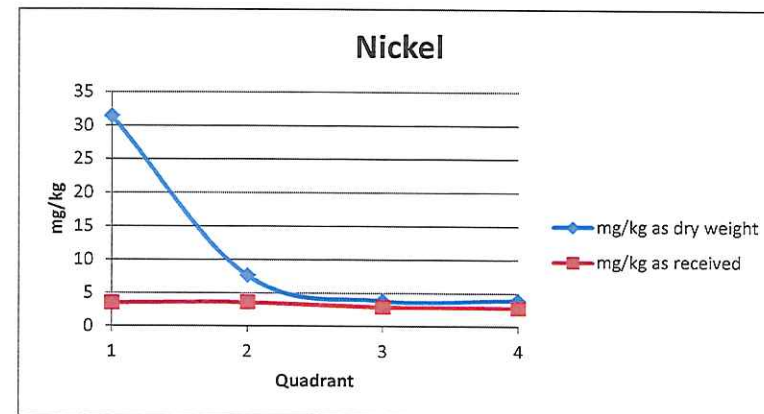
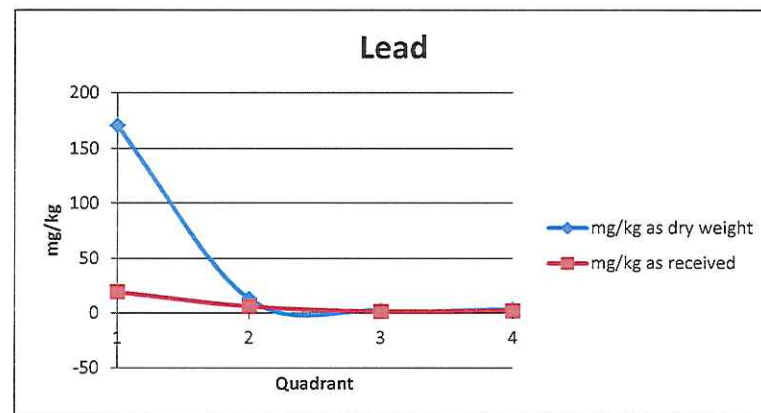
Paderewski Pond Sediment Sample Results Dry Weight vs. As Received

The four sediment samples were analyzed and reported on a “dry weight” basis, which is customary for all solid samples analyzed. After further review, it was determined that the samples should be calculated on an “as received” basis since this is their most representative state. This calculation was done by multiplying the results by the percent solids. A comparison between the “dry weight” values versus the “as received” values is included as Attachment D.

Based on the calculated “as received” values, all constituents evaluated, except for COD, were relatively consistent between each sample. COD in Quadrants 1 and 2 were significantly higher than in Quadrants 3 and 4. The inconsistency between the samples could be due to the amount of vegetation within each sample. COD levels are directly related to the amount of organic

compounds in water so if there were more nutrients within the sediment samples for Quadrants 1 and 2, this could increase the COD reported.

Copper, lead, nickel and zinc levels were slightly higher in Quadrants 1 and 2 but not of significance since the values reported were all below a concentration which adverse biological effects are likely to occur.
